Manhole Inspection Summary

Manhole # S350__037MH

Insp Date: **10/30/08 1:01 PM**

Location Address: **corner 800 light st**

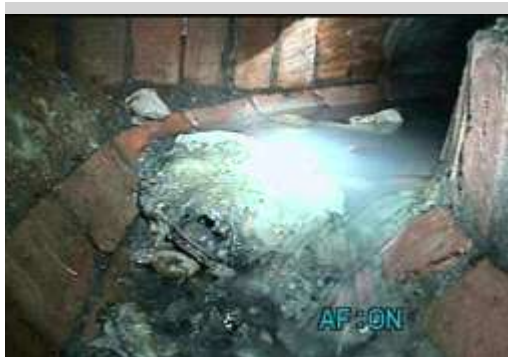
Defect 5

Condition: ☐ Sound ☐ Cracked ☐ Root Intrusion ☐ Deteriorated ☐ Leaks ☒ **Debris**

channel debris

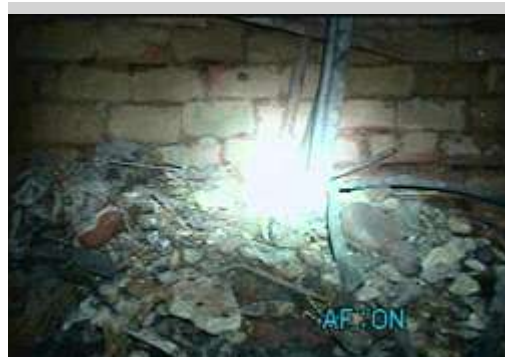
Defect 4

Condition: ☐ Sound ☐ Cracked ☐ Root Intrusion ☐ Deteriorated ☐ Leaks ☒ **Debris**

bench debris

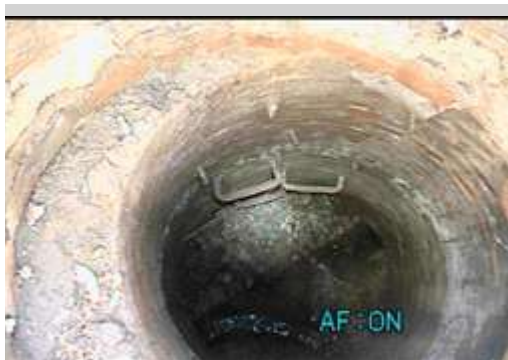
Defect 3

Count: **6** Missing: **3** ☒ **Corroded**

corr steps

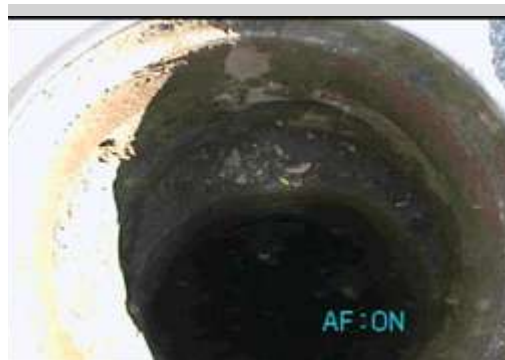
Defect 2

Offset: **5** (in.)

offset

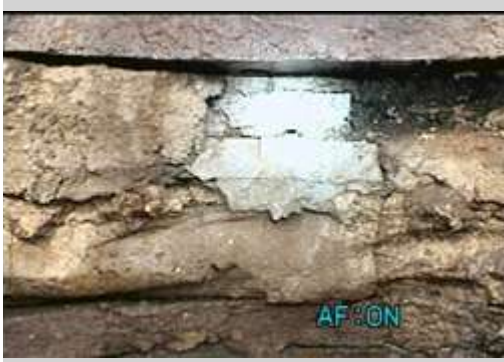
Defect 1

Condition: ☐ Sound ☒ **Cracked** ☐ Root Intrusion ☒ **Loose Brick** ☐ Deteriorated

cracked, loose bricks

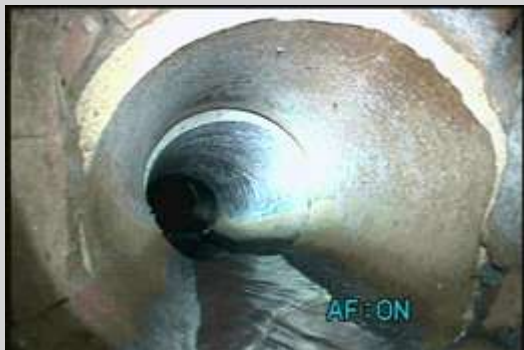
12 O'Clock Outflow

Pipe Material: **Clay** ☐ Pipe Lined

Invert Depth: 11.25 (ft.) Flow Characteristics: **Slow**

Deposits: ☒ None ☐ Mud ☐ Sludge ☐ Debris ☐ Grease

Infiltration: **None** Pipe Seal Cond: **Unknown**

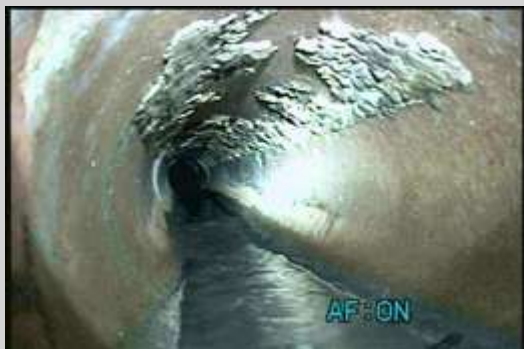
3 O'Clock Inflow

Pipe Material: **Clay** ☐ Pipe Lined

Invert Depth: 11.20 (ft.) Flow Characteristics: **Slow**

Deposits: ☒ None ☐ Mud ☐ Sludge ☐ Debris ☐ Grease

Infiltration: **None** Pipe Seal Cond: **Unknown**

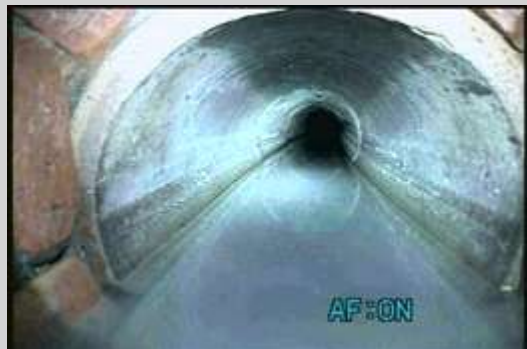
9 O'Clock Inflow

Pipe Material: **Clay** ☐ Pipe Lined

Invert Depth: **11.16** (ft.) Flow Characteristics: **Slow**

Deposits: ☒ None ☐ Mud ☐ Sludge ☐ Debris ☐ Grease

Infiltration: **None** Pipe Seal Cond: **Unknown**
